Lidar QaQc Report
Hawaii TO26: Big Island, Oahu, and Kauai
August 2007

EXECUTIVE SUMMARY

QAQC REPORT

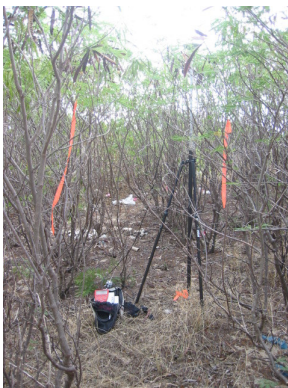
Moreover, one outlier was removed from the dataset for Oahu Island. This point has an error of 5.7 ft and the associated survey photo shows that this is a dense forested area (about 5 ft high estimated on Figure 20). We can notice on Figure 21, by comparing the Lidar model built with the extracted features files and the bare earth Lidar model, that the vegetation has not been extracted at the precise location of the survey point. This could explain the high discrepancy between the measured elevation and the Lidar elevation. This outlier survey checkpoint was influencing the overall Root Mean Square Error especially for the vegetated land cover type. Consequently, it has been discarded.

Figure 20 – Survey photo of outlier (point 103)

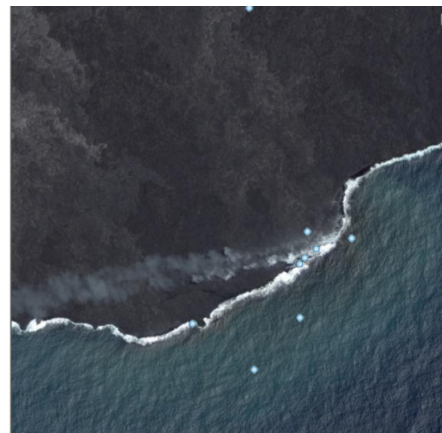
Sparse density along coast line occurred on a fairly large portion of the coast (Figure 30) in a volcanically active region (an eruption has occurred in August-September 2006 in East Ka'iili'Ili, correlation with the date of flight must be made). We therefore assume that the Lidar beam was stopped by fumes rising from the sea where lava encounters water as illustrated in Figure 31.

Figure 31 – Tile 10464, Low density of points and artifacts possibly caused by lava fumes

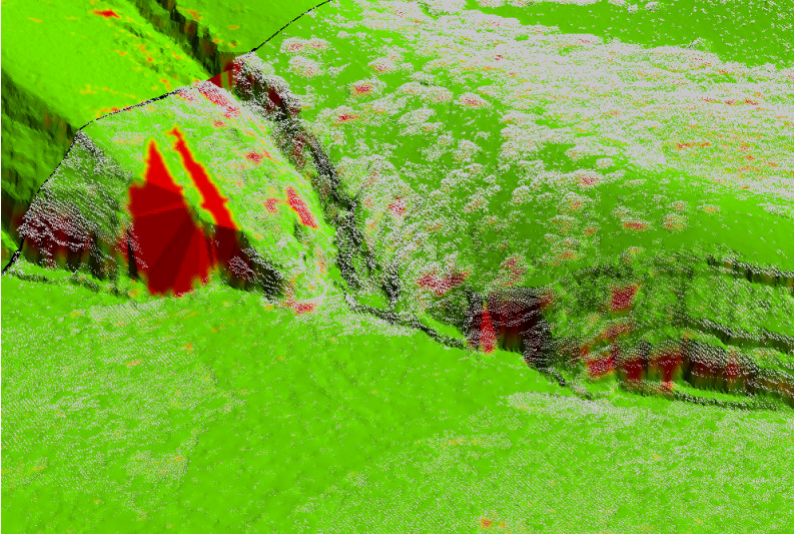
Figure 38 – Tile 2171; Data holiday. Bare earth models colored according to the density of points (red symbolized the lack of data), overlaid with the extracted points in white
